Remembering the Great Hanshin-Awaji Earthquake

On the occasion of the 30th anniversary of the Great Hanshin-Awaji Earthquake, this feature looks back on the mission we achieved in the aftermath of the quake based on excerpts from our 40th anniversary commemorative publication (published in 1998) and messages from our directors who experienced the disaster firsthand.

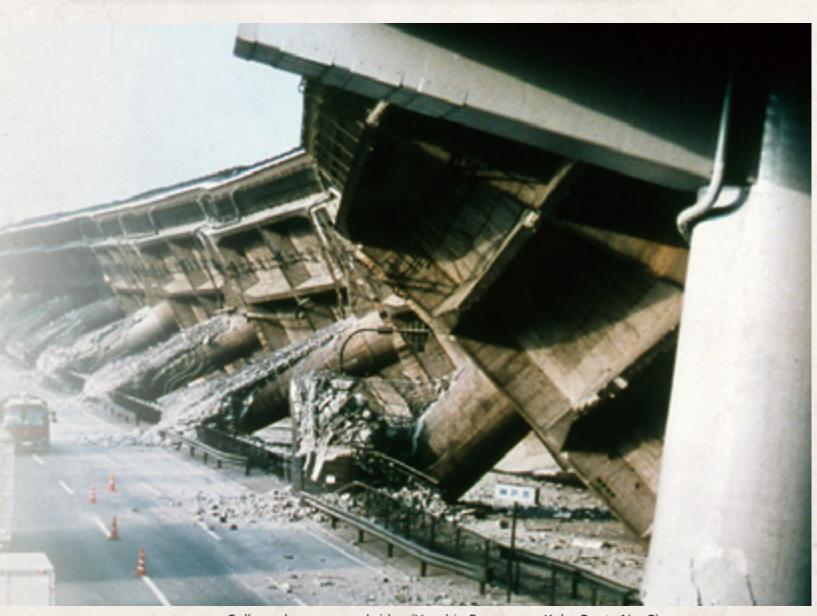
Collapsed expressway bridge (Hanshin Expressway Kobe Route No. 3)

This major earthquake was incredible even for SHO-BOND engineers who are experts in seismic reinforcement of structures At around 30 to 40 minutes after the earthquake, the expressway was reported to have broken off at the median strip and collapsed. Not believing the report. I rode my bicycle to Route 43 and found that the elevated piltz structure section of the Hanshin Expressway Kobe Route 3 had collapsed. The expressway structure had also fallen, the PC piers had sheared and collapsed, and the steel piers had buckled locally. I genuinely couldn't believe my eyes.

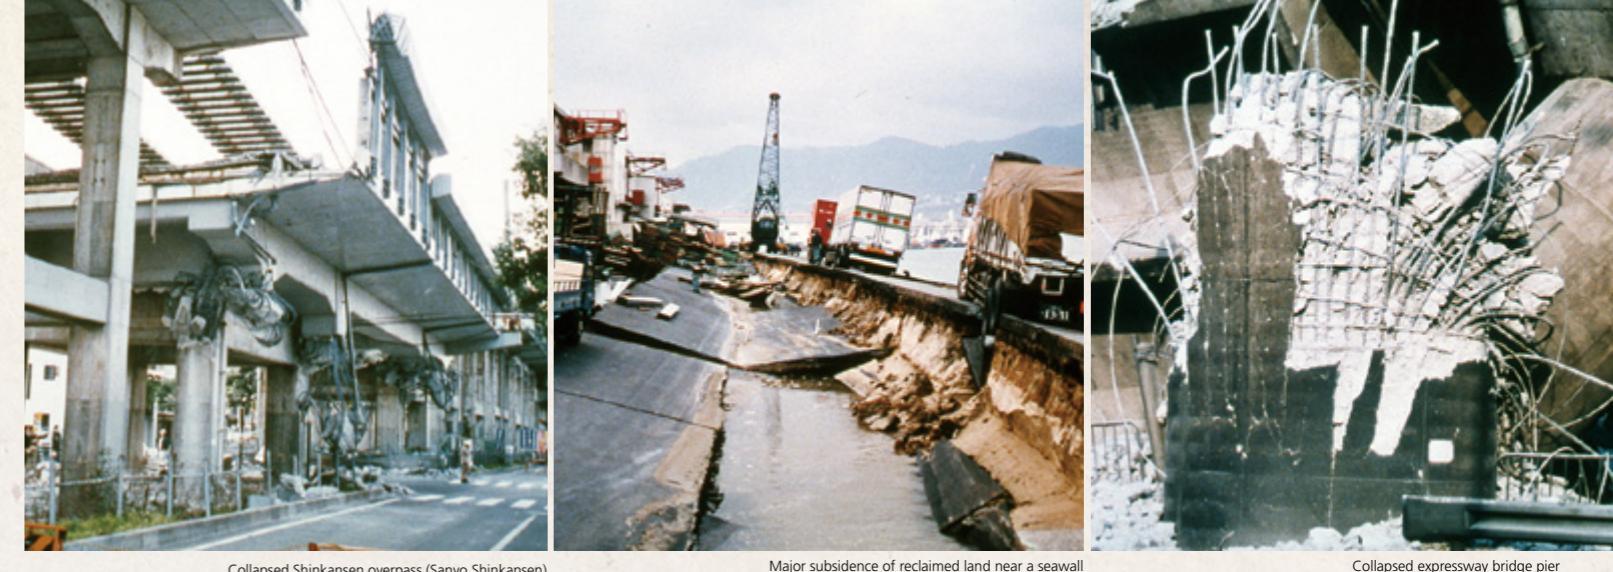
Collapsed Shinkansen overpass (Sanyo Shinkansen)

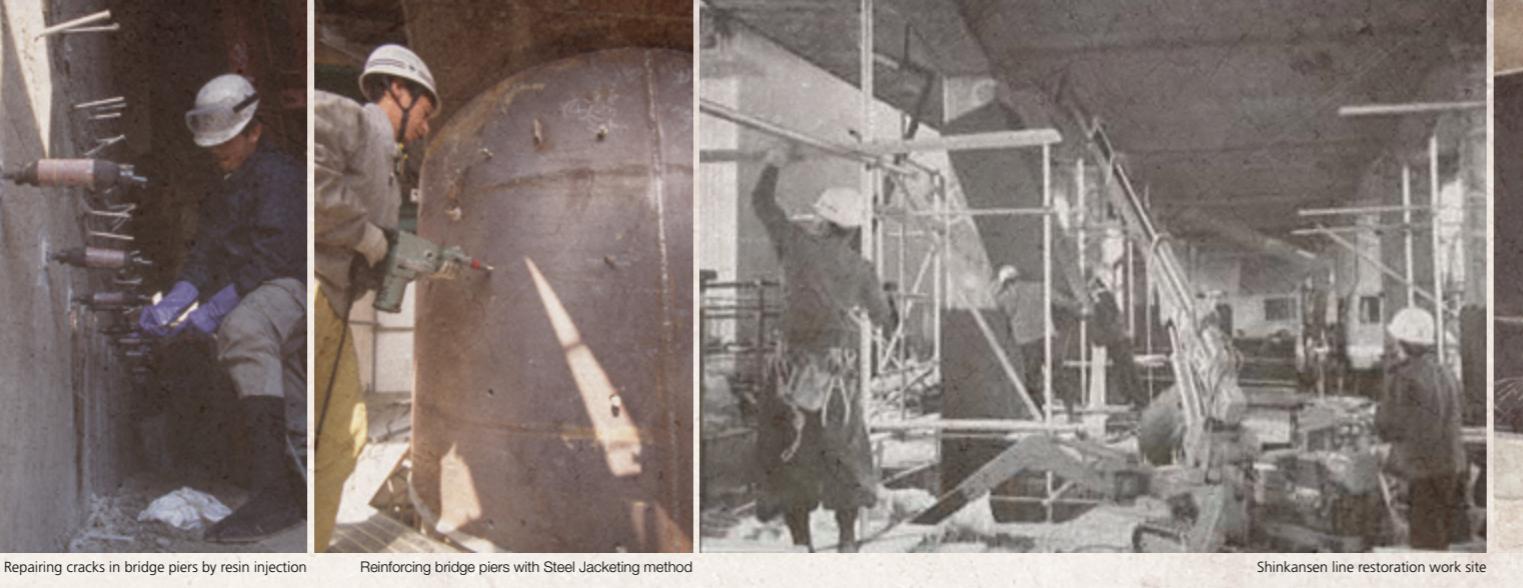
immediately prior to the earthquake

Coincidentally, SHO-BOND had been using the Steel Jacketing method to perform seismic reinforcement work on bridge piers near Tsukimiyama on the Kobe Route No. 3 of the Hanshin Expressway just prior to the earthquake in December 1994. While the piers that we had reinforced were not damaged in the Great Hanshin-Awaji Earthquake, the adjacent unfinished piers had sustained damage. The Steel Jacketing method consequently garnered increased attention as a method for reinforcing bridge piers against earthquakes, and it has since been adopted as a key method for earthquake restoration work. At the time, few construction companies had the technology and expertise to repair such structures, while we demonstrated our expertise as a maintenance specialist at each stage from the design to construction of emergency repair and reinforcement projects.
